## ROHS TEST REPORT

### Determination of Hazardous Substances TEST REPORT

Description of the appliance .... GASENGINES IGNITION SYSTEM

Model and/or type reference .. RCEXL A-01

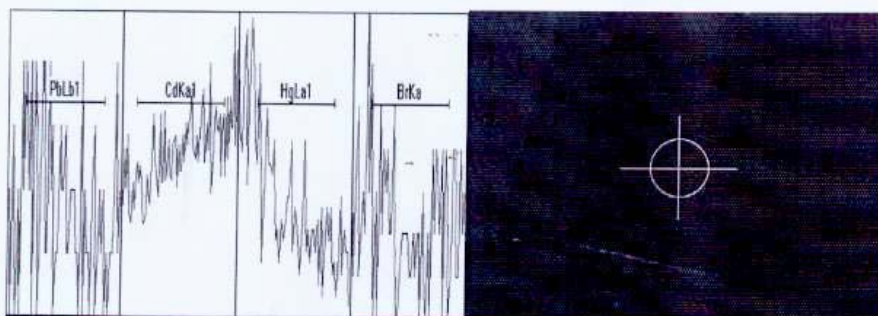
<Graph 01>

| Part | Specification | Test Item | Pb | Cd | Cr | Hg | Br |
|---|---|---|---|---|---|---|---|
| 1#<br>Enclosure | ABS | Result(ppm) | N.D | 9 | 224 | N.D | N.D |

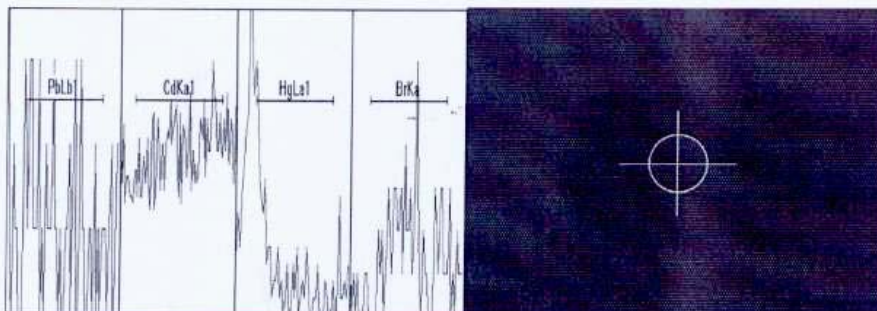
<Graph 02>

| Part | Specification | Test Item | Pb | Cd | Cr | Hg | Br |
|---|---|---|---|---|---|---|---|
| 2#<br>Signal wire<br>black<br>insulation | --- | Result(ppm) | N.D | 34 | 44 | N.D | 9 |

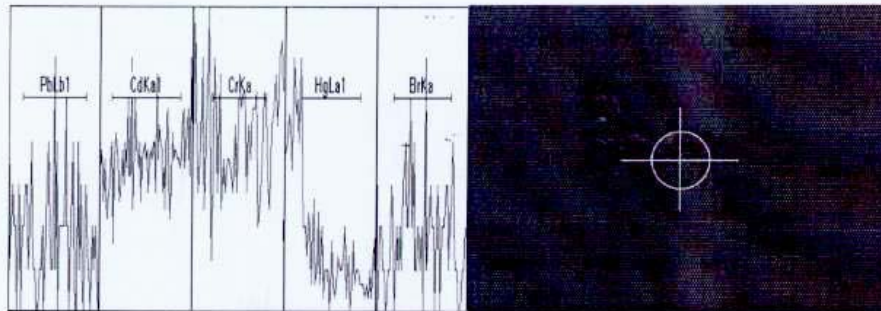
<Graph 03>

| Part | Specification | Test Item | Pb | Cd | Cr | Hg | Br |
|---|---|---|---|---|---|---|---|
| 3#<br>Signal wire<br>conductor | Copper | Result(ppm) | N.D | 20 | N.D | N.D | N.D |

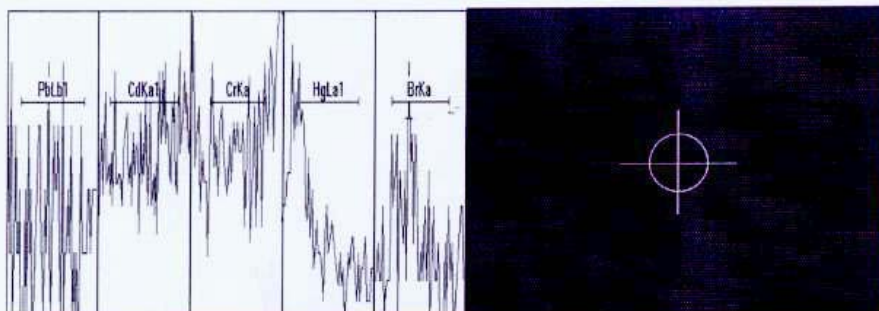
<Graph 04>

| Part | Specification | Test Item | Pb | Cd | Cr | Hg | Br |
|---|---|---|---|---|---|---|---|
| 4#<br>Signal wire<br>red<br>insulation | --- | Result(ppm) | N.D | N.D | N.D | N.D | N.D |

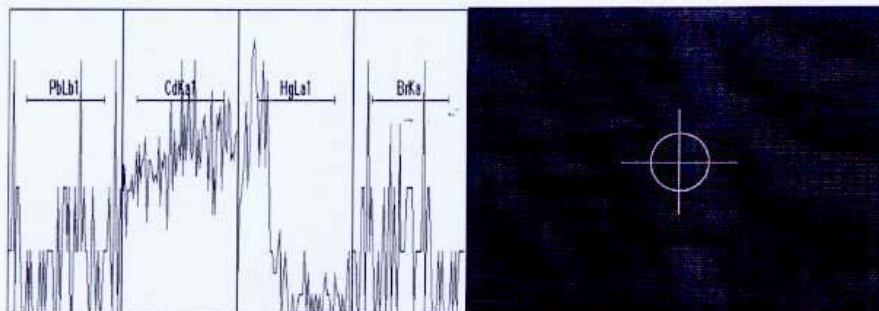
<Graph 05>

| Part | Specification | Test Item | Pb | Cd | Cr | Hg | Br |
|---|---|---|---|---|---|---|---|
| 5#<br>Signal wire<br>white<br>insulation | --- | Result(ppm) | N.D | 32 | 27 | N.D | N.D |

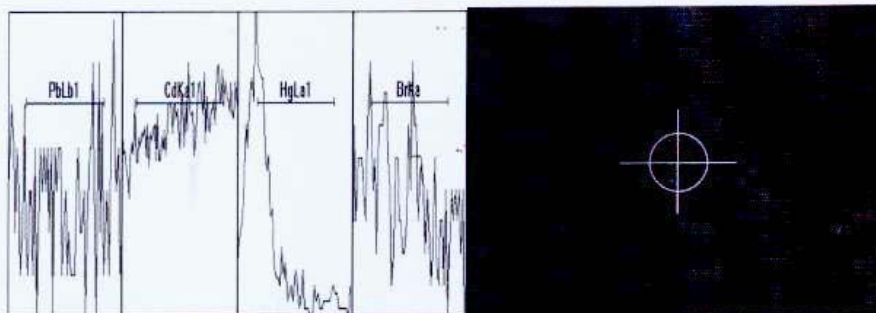
<Graph 06>

| Part | Specification | Test Item | Pb | Cd | Cr | Hg | Br |
|---|---|---|---|---|---|---|---|
| 6#<br>Red quick<br>connector | --- | Result(ppm) | N.D | 46 | N.D | N.D | N.D |

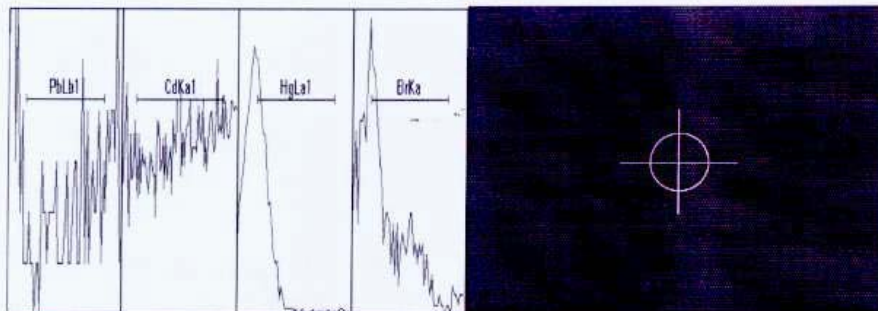
<Graph 07>

| Part | Specification | Test Item | Pb | Cd | Cr | Hg | Br |
|---|---|---|---|---|---|---|---|
| 7#<br>Black<br>quick<br>connector | --- | Result(ppm) | N.D | 19 | 54 | N.D | N.D |

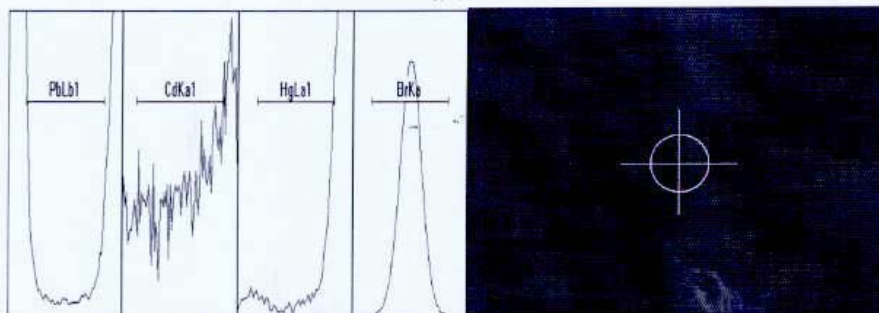
<Graph 08>

| Part | Specification | Test Item | Pb | Cd | Cr | Hg | Br |
|---|---|---|---|---|---|---|---|
| 8#<br>Red heat<br>shrinking<br>sleeve | --- | Result(ppm) | N.D | N.D | N.D | N.D | 580 |

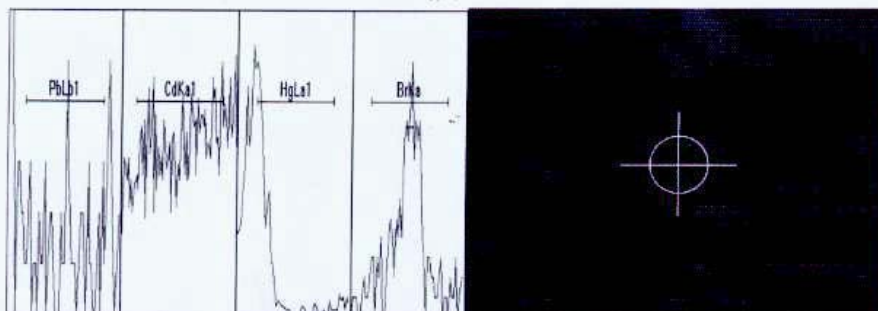
<Graph 09>

| Part | Specification | Test Item | Pb | Cd | Cr | Hg | Br |
|---|---|---|---|---|---|---|---|
| 9#<br>Black heat<br>shrinking<br>sleeve | --- | Result(ppm) | N.D | N.D | 18 | N.D | 9 |

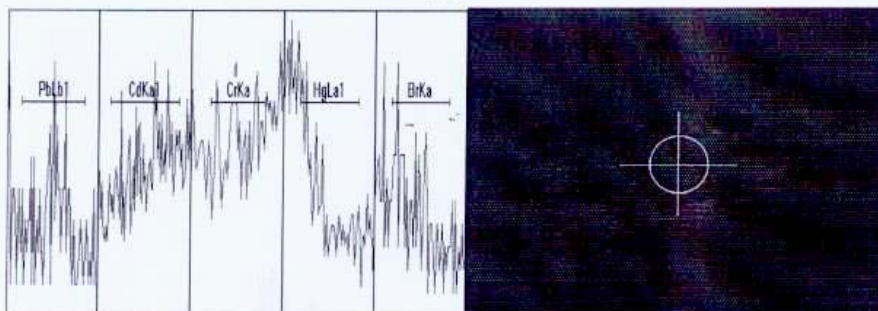
<Graph 10>

| Part | Specification | Test Item | Pb | Cd | Cr | Hg | Br |
|---|---|---|---|---|---|---|---|
| 10#<br>Argent<br>insulation<br>of the cord | FUTABA | Result(ppm) | 122 | N.D | N.D | N.D | N.D |

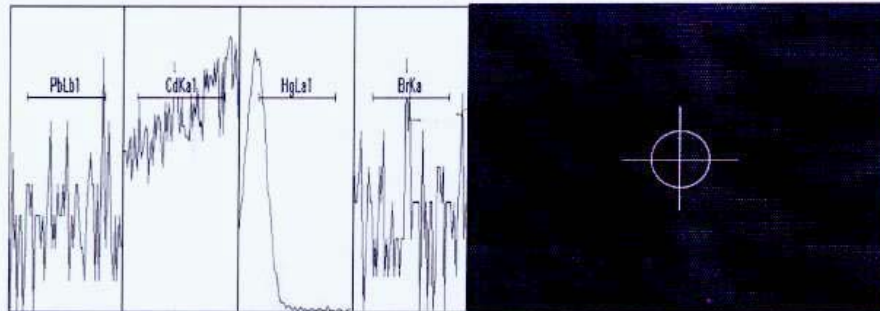
<Graph 11>

| Part | Specification | Test Item | Pb | Cd | Cr | Hg | Br |
|---|---|---|---|---|---|---|---|
| 11#<br>Black<br>insulation<br>of the cord | FUTABA | Result(ppm) | 7 | 12 | 24 | N.D | |

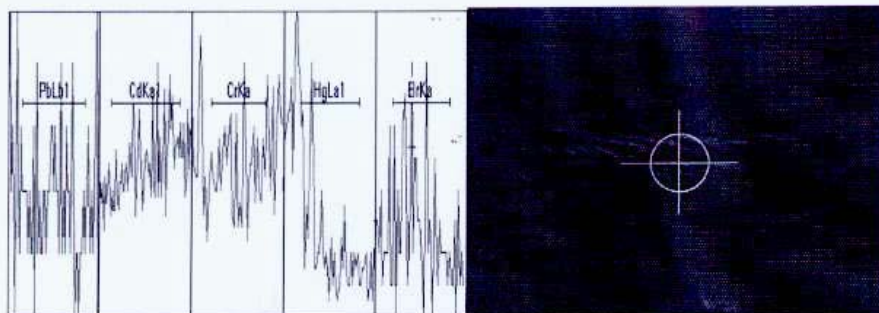
<Graph 12>

| Part | Specification | Test Item | Pb | Cd | Cr | Hg | |
|---|---|---|---|---|---|---|--|
| 12#<br>Conductor | FUTABA | Result(ppm) | 76 | N.D | N.D | N.D | |

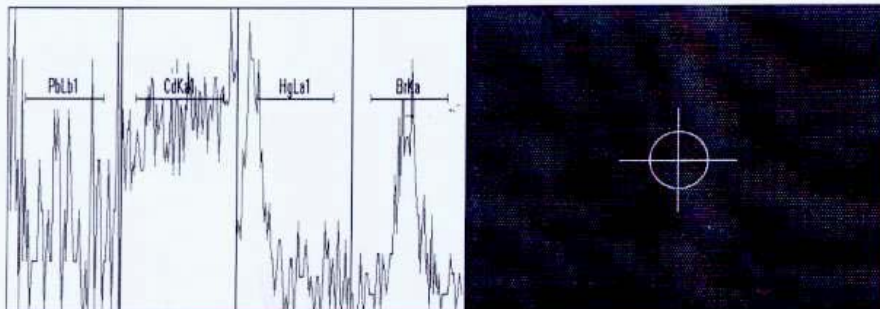
<Graph 13>

| Part | Specification | Test Item | Pb | Cd | Cr | Hg | Br |
|---|---|---|---|---|---|---|---|
| 13#<br>Sealed ring<br>in stainless<br>steel cover | Rubber | Result(ppm) | 9 | 12 | N.D | N.D | 22 |

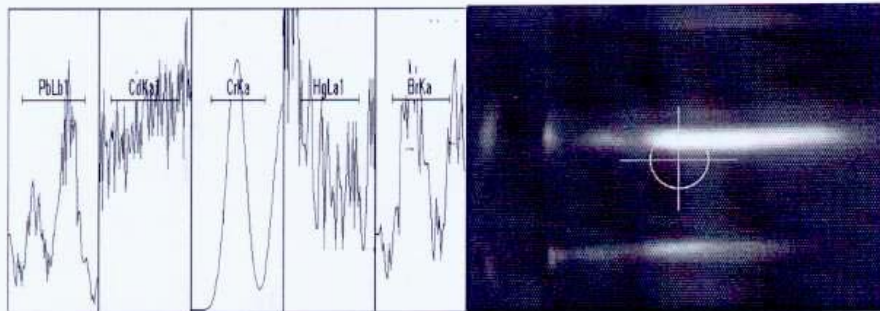
<Graph 14>

| Part | Specification | Test Item | Pb | Cd | Cr | Hg | Br |
|---|---|---|---|---|---|---|---|
| 14#<br>Stainless<br>steel cover | Steel | Result(ppm) | N.D | N.D | N.D | N.D | N.D |

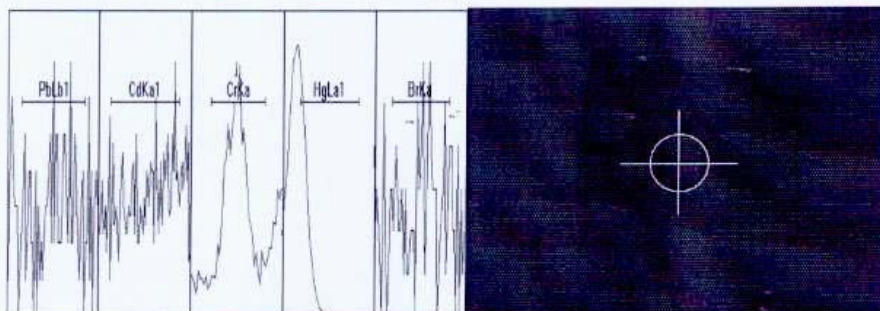
<Graph 15>

| Part | Specification | Test Item | Pb | Cd | Cr | Hg | Br |
|---|---|---|---|---|---|---|---|
| 15#<br>Button on<br>stainless<br>steel cover | Metal | Result(ppm) | 170 | N.D | 71 | N.D | N.D |

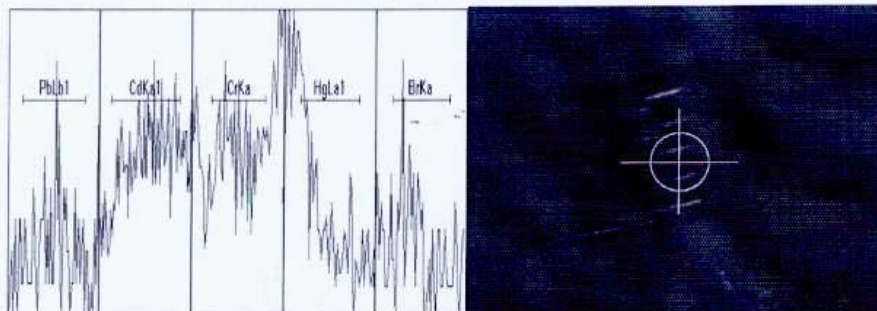
<Graph 16>

| Part | Specification | Test Item | Pb | Cd | Cr | Hg | Br |
|---|---|---|---|---|---|---|---|
| 16#<br>Spring on<br>stainless<br>steel cover | Metal | Result(ppm) | 141 | N.D | N.D | N.D | N.D |

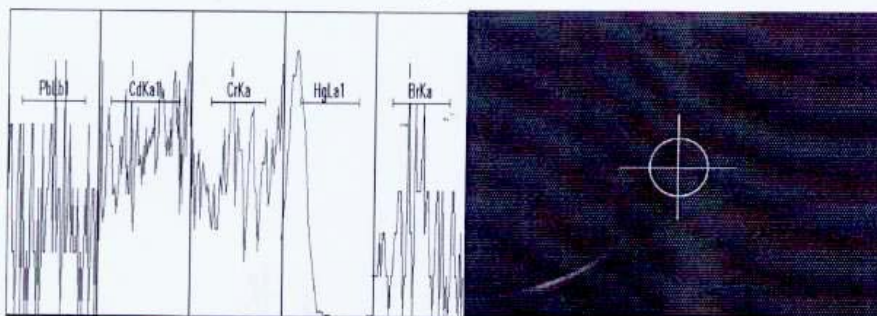
<Graph 17>

| Part | Specification | Test Item | Pb | Cd | Cr | Hg | Br |
|---|---|---|---|---|---|---|---|
| 17#<br>Ring on<br>stainless<br>steel cover | Metal | Result(ppm) | N.D | N.D | N.D | N.D | N.D |

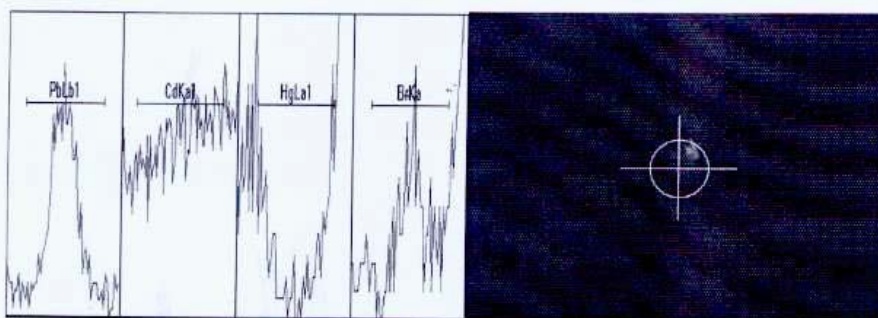
<Graph 18>

| Part | Specification | Test Item | Pb | Cd | Cr | Hg | Br |
|---|---|---|---|---|---|---|---|
| 18#<br>High<br>voltage<br>transforme<br>r | --- | Result(ppm) | 73 | N.D | 11 | N.D | 7 |

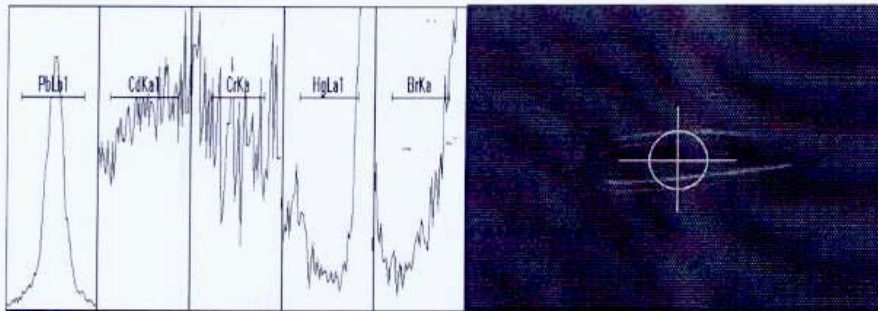
<Graph 19>

| Part | Specification | Test Item | Pb | Cd | Cr | Hg | Br |
|---|---|---|---|---|---|---|---|
| 19#<br>Tin | SnCu0.7 | Result(ppm) | N.D | N.D | N.D | N.D | N.D |

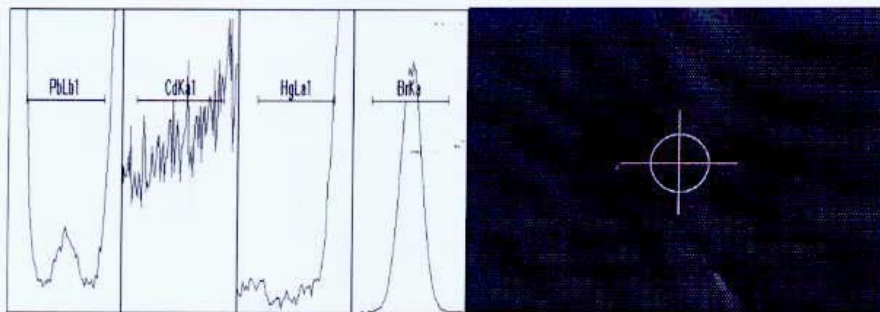
<Graph 20>

| Part | Specification | Test Item | Pb | Cd | Cr | Hg | |
|---|---|---|---|---|---|---|--|
| 20#<br>PCB | --- | Result(ppm) | 743 | 8 | 115 | N.D | |

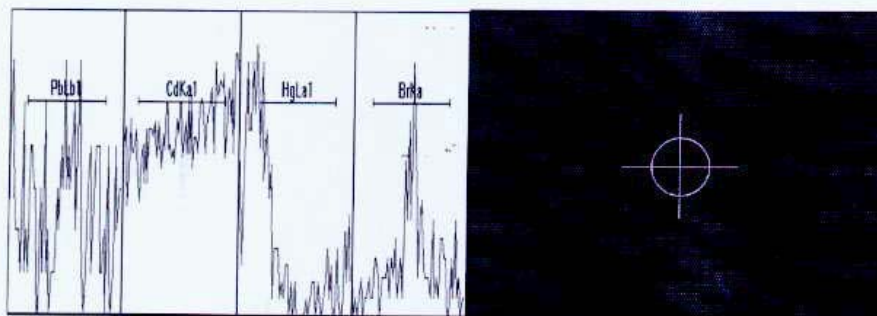
<Graph 21>

| Part | Specification | Test Item | Pb | Cd | Cr | Hg | Br |
|---|---|---|---|---|---|---|---|
| 21#<br>Bobbin | --- | Result(ppm) | 9 | N.D | 28 | N.D | N.D |

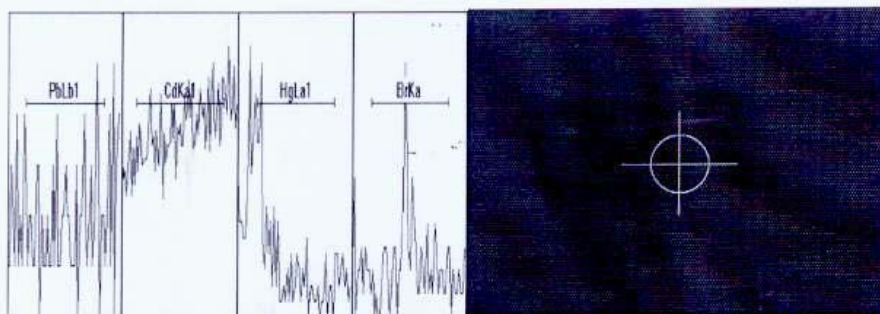
### CCD Picture:

| Part | Specification | Test Item | Pb | Cd | Cr | Hg | Br |
|---|---|---|---|---|---|---|---|
| 23#<br>Capacitor | C1 | Result(ppm) | 6 | 11 | N.D | N.D | 11 |
| | | Judgment | P | P | P | P | P |
